Village of Spring Lake

Parks & Recreation Board Meeting

December 1, 2014

**Subject: Mill Point Park Floating Docks
Engineering Evaluation**

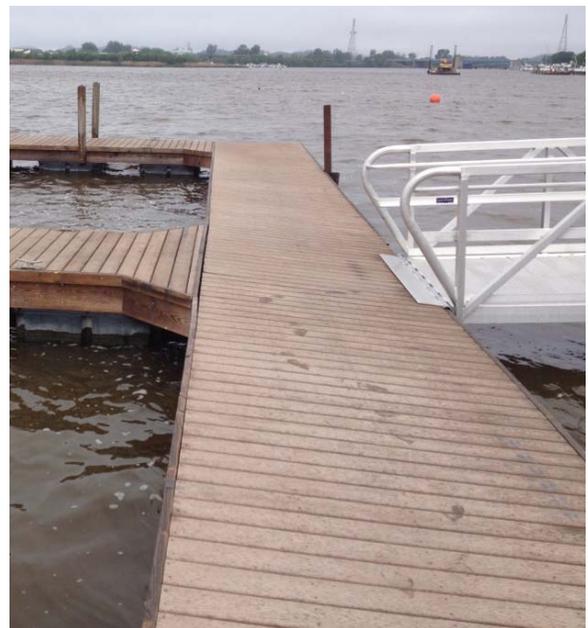
Figure 2

The dock floatation is not sufficient for gangway load, causing a depression in the dock at the gangway landing (Figure 2). If left in this condition, frame damage can be expected, if it has not already occurred.

We recommend adding commercially-available floatation units (Figure 7) to the dock system at the gangway landing or replacing existing units with deeper units. This work may require reconfiguration of the existing floatation units to make room for the additional units. The weight of the gangway should be obtained from Raven Marine to calculate the anticipated dead and live loads acting on the dock at the gangway landing. This information can be used to determine the proper level of floatation at the landing. The cost for floatation units varies with size, but each tub typically costs \$250 to \$500.

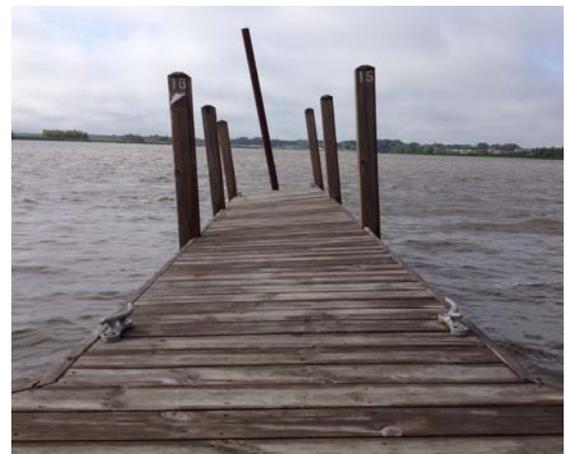
Figure 3

At the park location, finger piers are exposed to river currents. The direction of these currents likely varies based upon river flow and wind direction. The anchorage system utilizes "spud" pile anchors, which are not rigid and allow the docks to move several feet, based upon the direction of current. In these dynamic conditions, the anchorage system appears to be insufficient. Some dock frame damage is exhibited by twisted finger piers (Figure 3) and additional damage may occur.

We recommend replacing the current anchorage system with a system that will hold the docks in place horizontally and allow free vertical movement. Given the perceived river flow conditions, the best anchorage system is likely a guide pile system (Figure 8). This system consists of a driven piles and guides mounted to the dock system. This system could be designed to incorporate guides which can be opened/removed during winterization to allow the docks to be relocated to a protected location, as they are now. The pile size and quantity must be properly designed to accommodate the range of anticipated conditions. At minimum, 3-4 guide piles will be required for each of the two dock systems. The cost for each pile and guide is approximately \$1,500-\$2,500, resulting in a total cost of \$10,000 to \$20,000 for replacing the anchorage system.

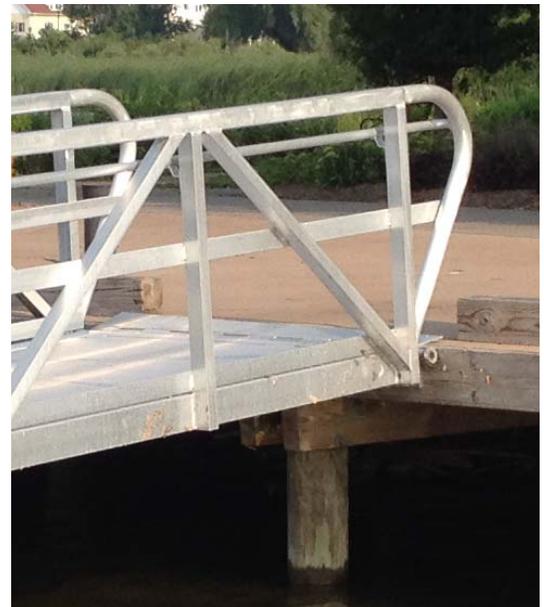
Figure 4

The two gangways that allow access to the docks from land are rigidly connected to both the docks and to land-side features. The existing connections allow movement in only the vertical direction, using hinges (Figure 4). However, the dock anchorage system discussed above allows docks to move horizontally with water current conditions, placing stress on the gangway connections, the gangway frames, and the dock frames. Typically gangways and their connections are not designed/constructed to constrain or anchor the docks. The existing configuration may result in damage to the gangway connections, gangway, and/or the docks.

If the dock anchorage is corrected to prevent horizontal movement of the docks, the connections may not require correction measures. If correction measures are necessary, the following should be considered:

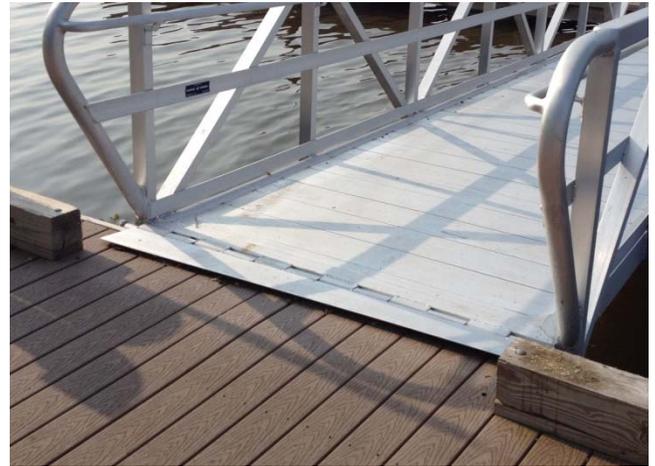
Figure 5

Each of the four gangway connections includes a transition plate, which is intended to provide a transition from the level landing or dock to the sloped surface of the gangway. The free end of the transition plate should rest upon the level surface of the landing or dock. However the existing transition plates do not appear to be performing at intended, as the free ends are suspended above the flat surface (Figure 5). This condition creates a trip hazard and an ADA-compliance issue. This condition appears is likely a result of one or more of the conditions described above.

This condition will likely be resolved by the measures identified above and we do not recommend addressing this issue until other modifications are completed.

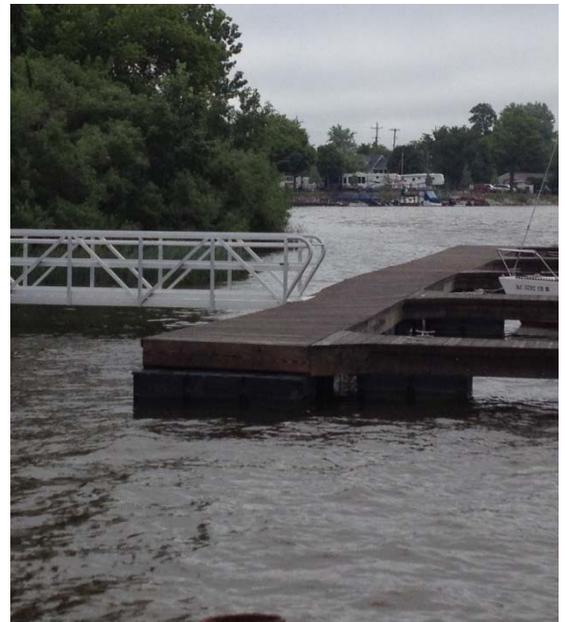
Figure 6

One floatation unit appeared to be loose/disconnected from the easterly dock system (Figure 6). This issue commonly results from ice forces during spring ice flows; however we understand these docks are relocated to a protected location during the winter months.

The floatation unit should be inspected for damage and re-fastened to the floating docks if it has not been damaged. If damage is observed, the floatation unit should be replaced.
